Fitting Out Benchmark
& Assessment Tool

Pilot Assessments

[Corporate Occupier 3] offices fit-out – ‘Ska’ Rating & Benchmarking Pilot

Handover Report

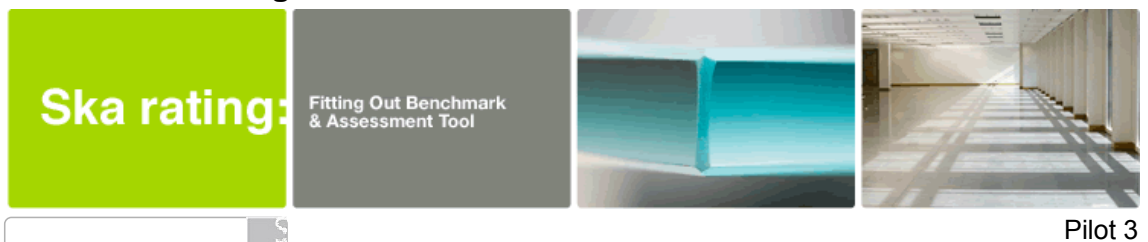
3.1 Benchmark Rating & Label

Rating: **Improved**

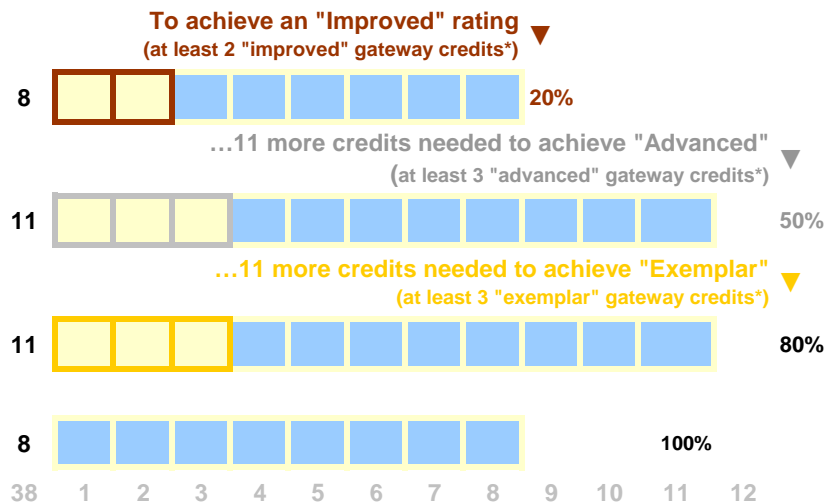
5. Determine the number of gateway and other credits needed to achieve each rating. The boundaries are based on a percentage of the available credits...

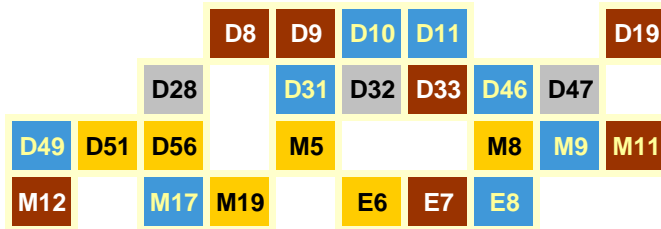
[Pilot 3] actual scoring

6. Assess and score the fit-out based on information collected during the project and determine the rating achieved...

38 available credits including: 9 improved, 5 advanced and 12 exemplar gateway credits

- 2 improved gateway credits
- 2 advanced gateway credits
- 5 exemplar gateway credits
- 4 other credits

"Improved" rating achieved ▼

[Pilot 3]	Good practice measures			
	Total in pool	In scope	Pilot score	% achieved
Totals	97	38	13	34%
Rating	C – Improved
